# The Staples and Covell Train Wreck of 1894

AN ANALYSIS SUPPORTING A LOCATION CORRECTION

Tom Eitnear  
2021

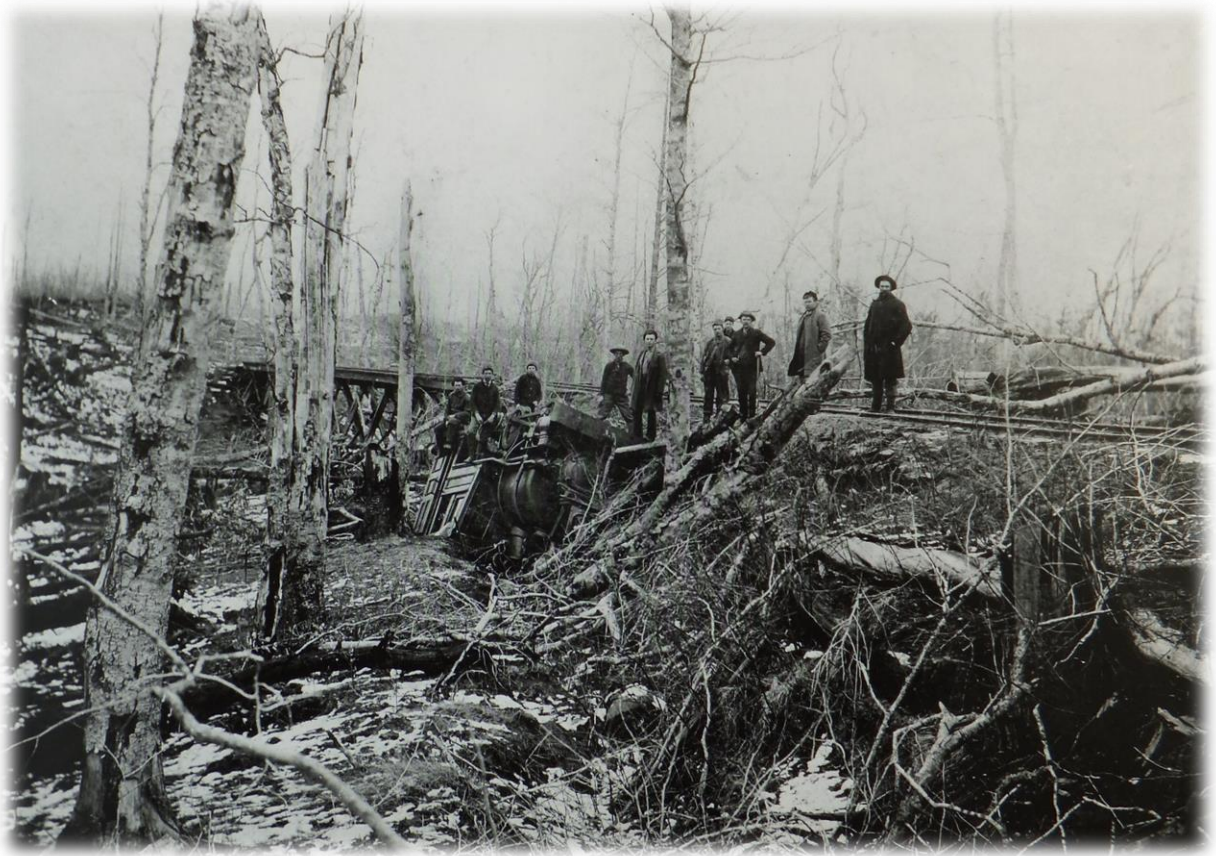
The only known photograph of the train wreck, as seen on the cover page of this document, was judiciously analyzed for inconsistencies with known information as well as information from newspaper articles and other publications. Some assumptions were required for completion of this analysis.

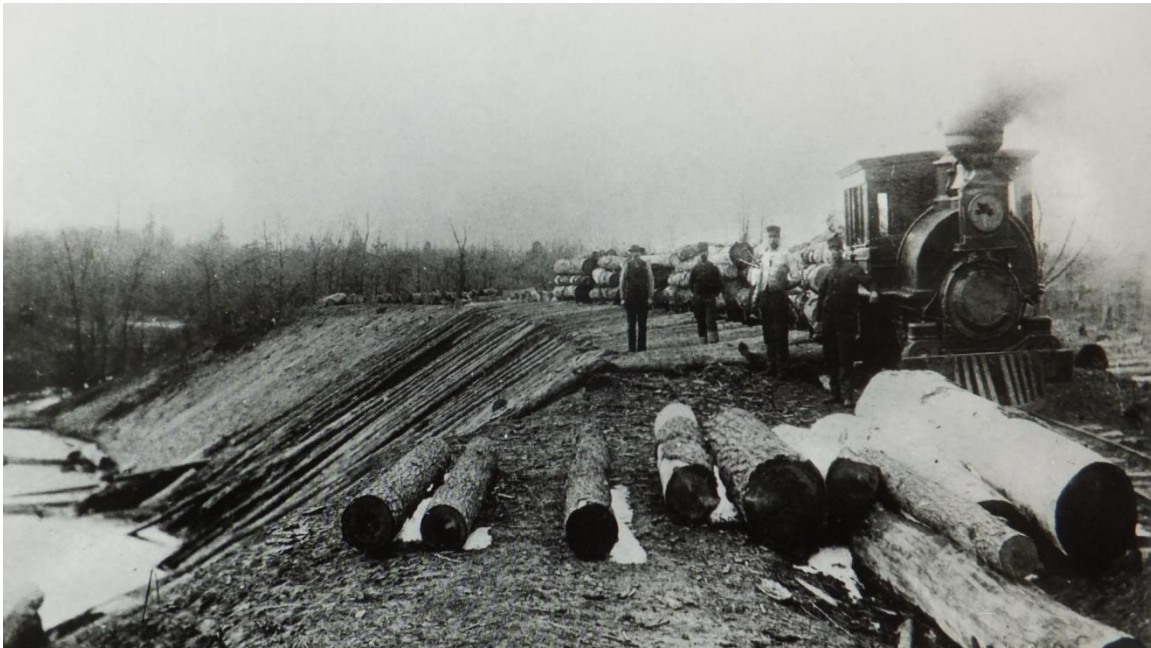
Figure 3. Staples and Covell log rollway at the White River

Logs were cut and piled near the railroad spurs during the winter months. When the grip of winter started to fade, the logs were loaded onto rail cars and transported to the rollways along the

White River where they were rolled into the river to take advantage of the copious water levels resulting from the spring melt and dam releases.

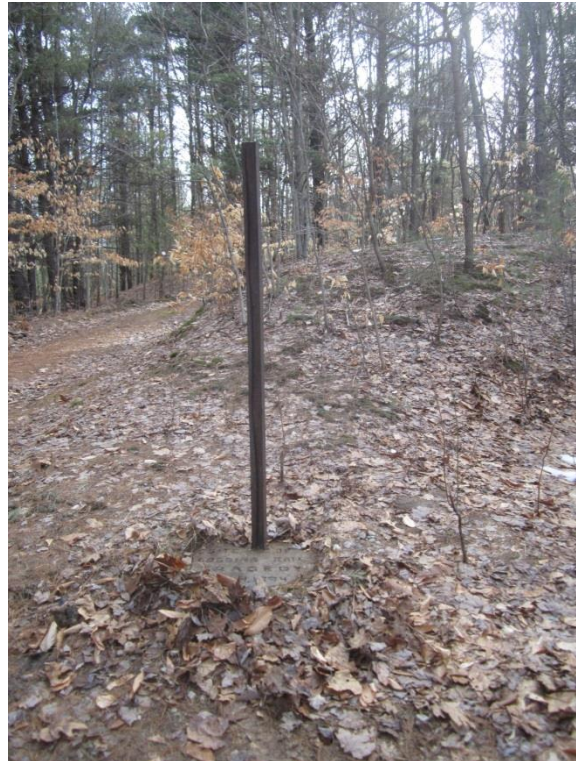
Figure 4. Train wreck marker

The November 6, 1990 edition of the Muskegon Chronicle ran an article authored by Barb Aardema describing the Staples and Covell train wreck of 1894 and how a Rothbury man created a monument to mark the location of the wreck. Henry Fischer, a local lifelong resident in the area, created a simple monument made of concrete and a 6 foot section of rail from the historical railroad. He placed this monument at a site where he thought the wreck occurred, and this site has been recorded at the Oceana County Historical Society headquarters as being located 650 west and 900 feet north of the southeast corner of section 35 of Shelby Township.

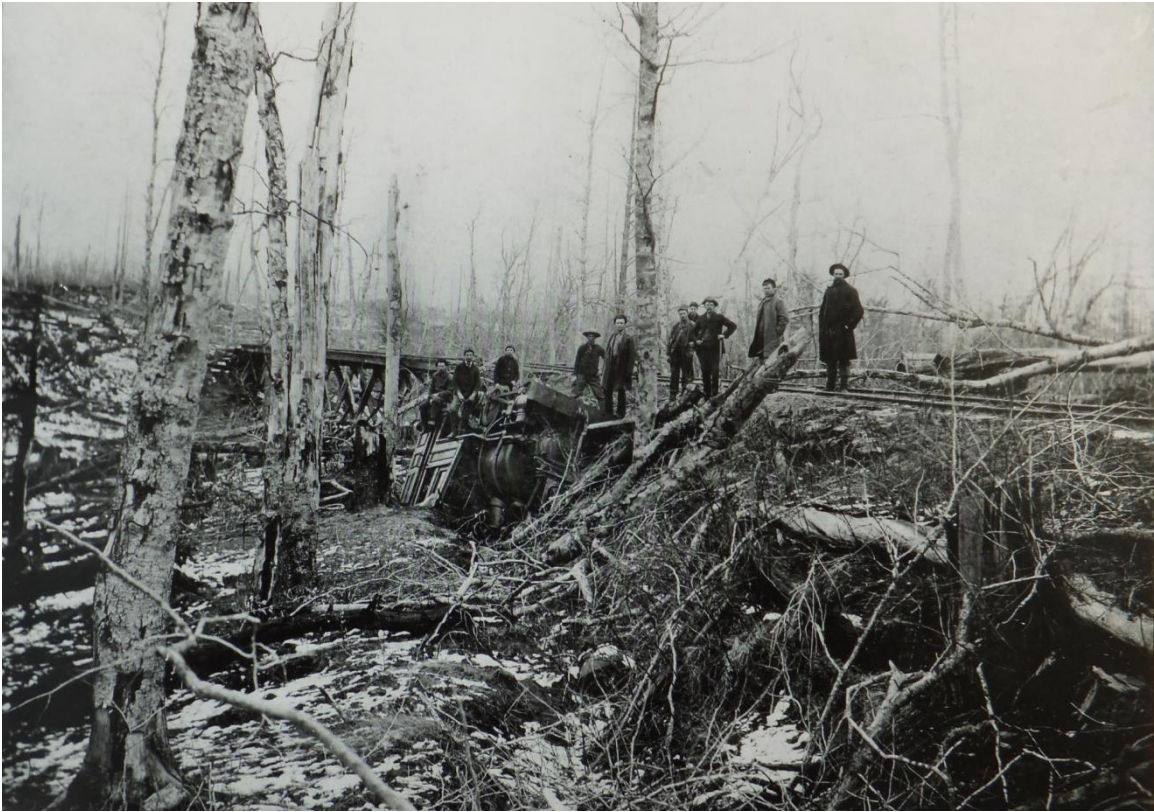
Figure 6. Train wreck photo showing the full trestle

also ran an article about the wreck which also included a photo of the wreck...the same photo used by the Oceana Herald 19 years earlier. Both of these respective photos were cropped images and fail to show the far end of the trestle as compared to Figure 6 below.

It is probable that Henry Fischer had in his possession one of these newspaper photographs since research has not found any other newspaper printing of the wreck photograph prior to 1990, or for that matter any other photos of the wreck. Henry would have been unable to determine the length of the trestle using either of the newspaper photographs since the far end of the trestle was not shown respectively.

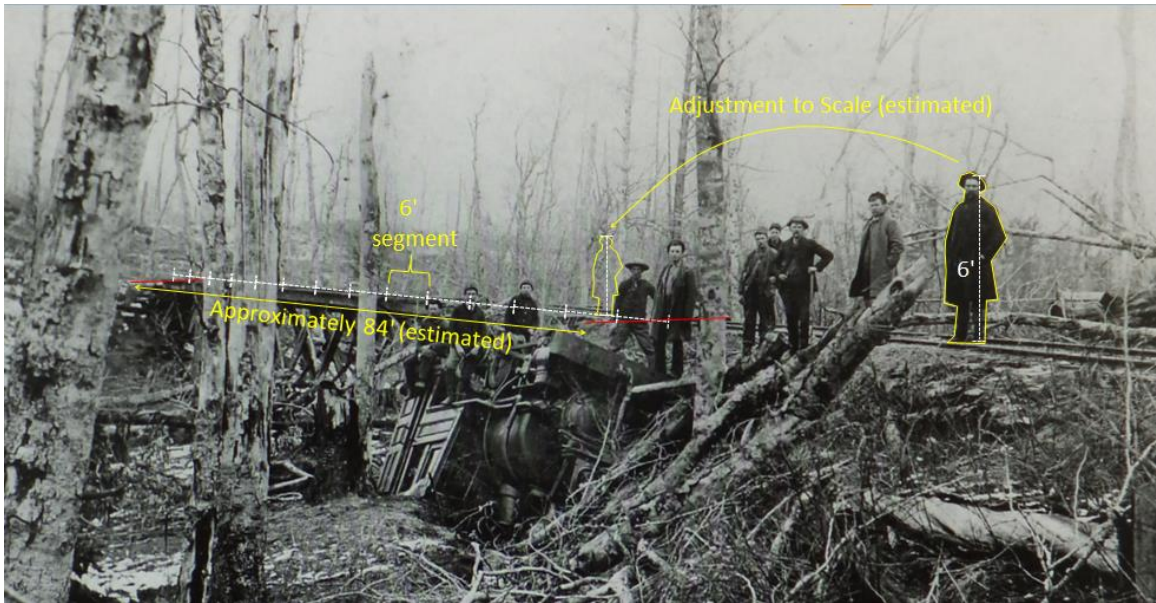
Figure 8. Scale estimation of the trestle length

Figure 8 shows an estimate of the trestle length utilizing the scale of one of the individuals in the photo. An assumption is made that the man at the far right in the photo is 6 foot tall. The outline of this man is reduced when moved to the trestle because the scale of depth increases as one moves across the trestle away from the locomotive. The farther along the trestle the outline is moved the smaller the outline would become.

The 6 foot segment measuring the height of the man is used to provide an estimate of the trestle length. The ends of the trestle are marked with a red line, and multiple 6 foot segments were placed end to end adjusting for the scale of depth. Fourteen segments made up the distance totaling approximately 84 feet, which is closer to the measured distance of Site B as noted in Figure 7.

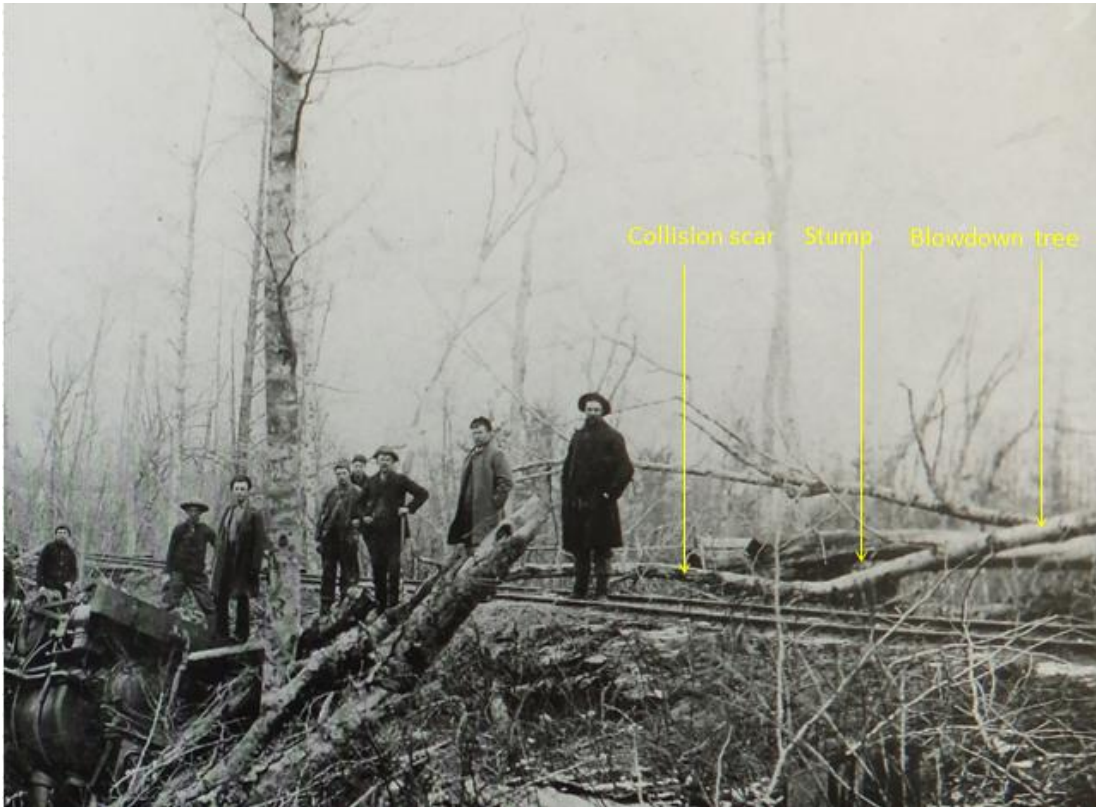
Figure 10. Train wreck photo with the stump and tree identified

The orientation of the track at Site A is nearly North/South and the strong east breeze would have blown the tree down nearly perpendicular to the track, whereas at Site B the breeze would have blown the tree down at an angle, or diagonally, to the track. This diagonally placed tree is evident in Figure 10.

Close observation of Figure 10 shows a stump that may have kept the tree limb from being swept off to the side of the track upon collision. There is also a collision scar on the limb.

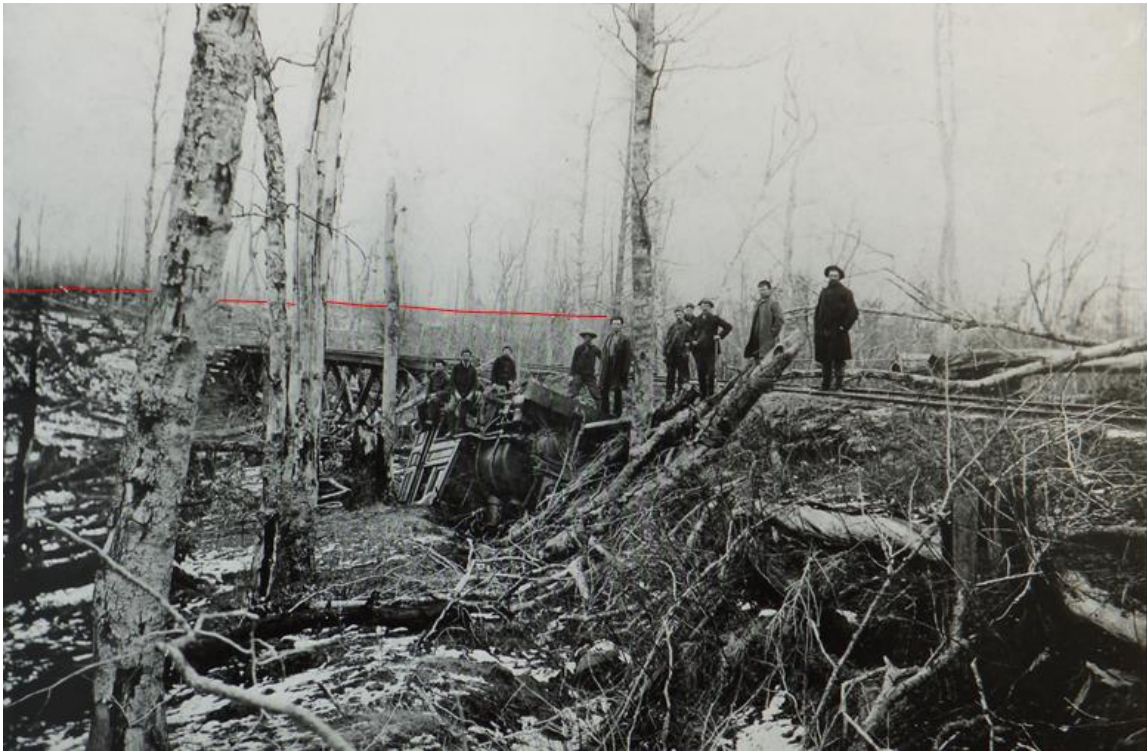
Figure 11. Train wreck photo with the background horizon identified

Additional evidence that Site B is the correct wreck location can be seen when examining the background horizon of the train wreck photograph. This horizon is identified by the red line in Figure 11. The horizon shows the sweeping hilltop of the background hillside. When the photograph angle is taken into consideration and compared to the relief map (Figure 12) it is evident that the sweeping hillside is present in the background at Site B. The background at Site A is characterized as a pothole swamp and is not evident in the train wreck photo.

There is a slight amount of snow on the ground in Figure 11. Close observation shows some snow on the hillside in the background just beneath the red line. If this photo was taken at Site A there would not be any snow seen in the background because there was no sweeping hillside.

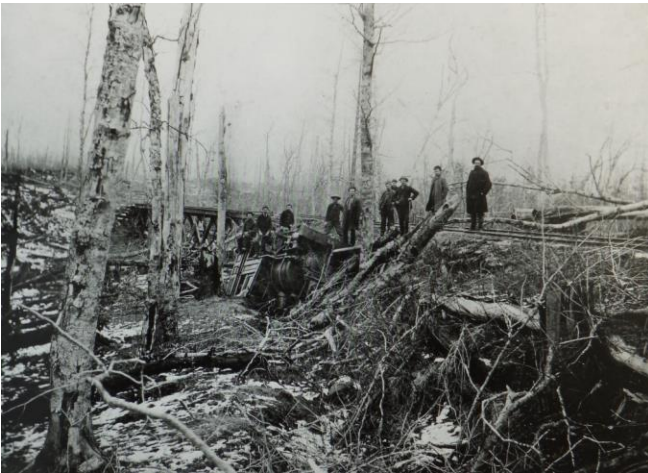
April 1894

There is an ample supply of conflicting information to be found in newspaper articles printed after the accident and years thereafter. The best evidential information is the actual train wreck photo since it can only be interpreted at face value, and is not reliant on third party authenticity.
